# Kirklees Council Flood Investigation *6 Enfield Close, Batley*

Flood Management and Drainage Team  
Kirklees Council  
1/23/2012

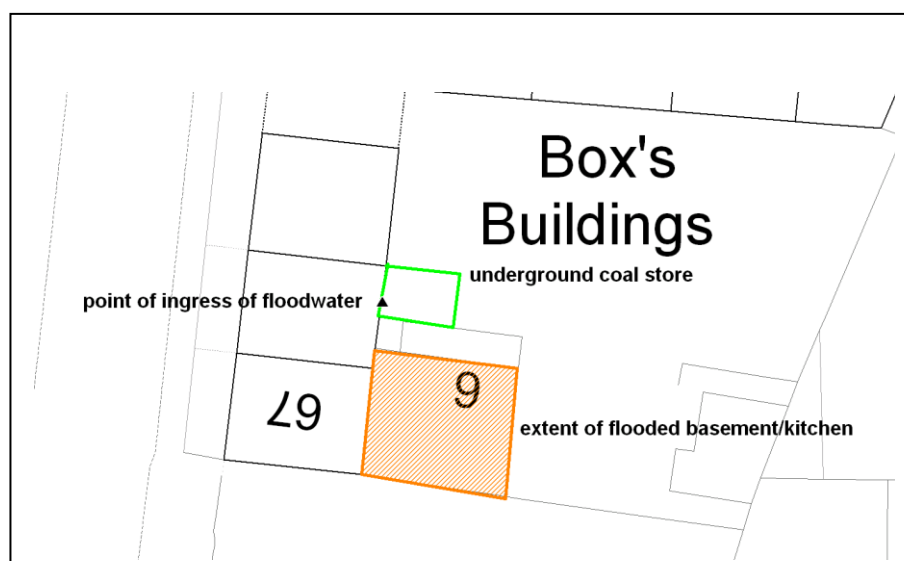
Location and Extent of Flooding

Flooding occurred to the basement of 6 Enfield Close, one of a block of late 19<sup>th</sup> century properties, on 4 January 2012. The basement to the property is used as a kitchen, accessed externally from a flight of steps. The floor in the kitchen is approximately 2m below the external ground level in the courtyard to the block of properties. It appears that the source of the floodwater was from an unused underground coal store adjacent to the foot of the steps with a ground level similar to the basement level. Water was observed by the resident to be issuing from a side wall in the store at a rapid rate, entering the basement area and filling it to a depth of 75mm before receding. The resident had to use two small pumps to minimise the amount of flooding but the depth only reduced as the flow into the cellar reduced. Flooring, kitchen units and several white appliances were destroyed from the event. Neighbouring properties have similar basements with similar floor levels, many used as habitable rooms. It appears that 4 Enfield Close reported water entering the basement but there have been no reports of flooding to the other properties.

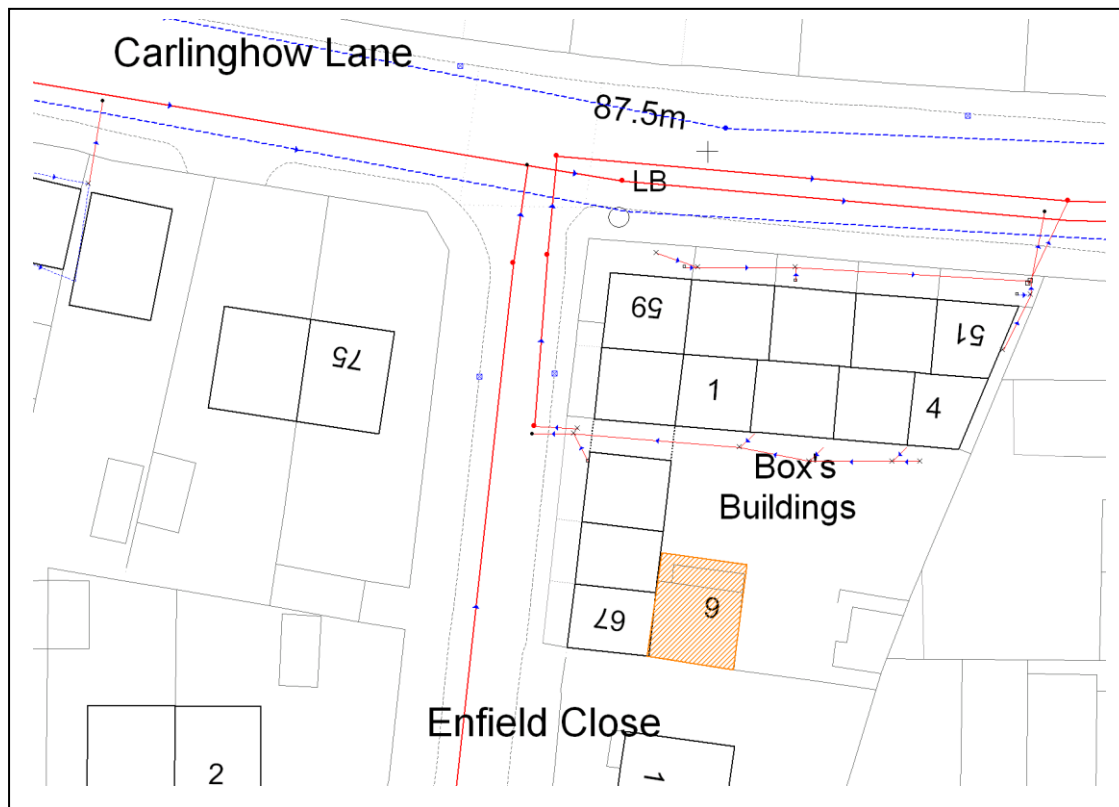
### Description of Drainage Systems in the vicinity

**Yorkshire Water Drainage Systems** – The plan above shows the recorded extent of the public sewer network in the area. The thin red lines near the properties indicate the drainage serving the individual properties (Known as “Section 24” drainage). The thicker red lines are the main combined (foul and surface water) public sewers. The dotted blue lines are surface water public sewers.

The surface water sewer nearest to Box’s buildings is an old square section stone slab culvert dating back to pre 1850. It may well be related to the previous site features (well and mill) referred to in the **Unrecorded Drainage Systems** referred to below.

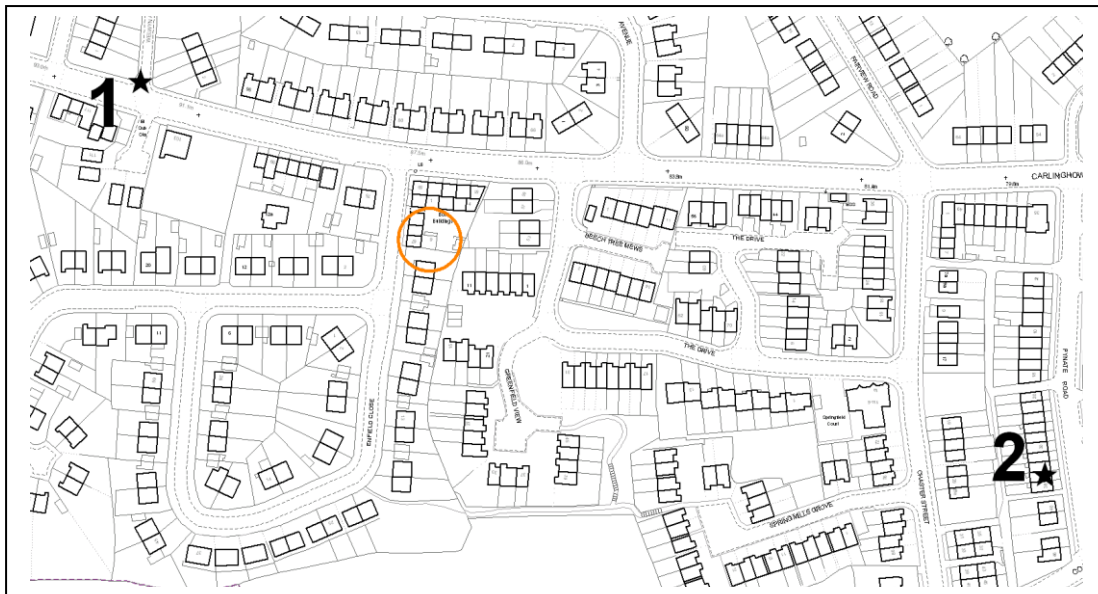
### Location of Council recorded flood incidents near to 6 Enfield Close

Incident 1 – Blocked road gully on Carlinghow Lane, Aug 1999

Incident 2 – Flooded cellar, June 2008

In summary, there is little recorded history of flooding in the area, either to properties or overland surface flooding.
