**ARBORICULTURAL IMPACT ASSESSMENT
to BS 5837:2012
at
New Hey Road
Salendine Nook
Huddersfield
West Yorkshire
HD3 4GS**

JCA Ref:
16383-A/AJB

**Appendix 6:
Tree Constraints Plan**

Appendix 7: Arboricultural Implications Plan

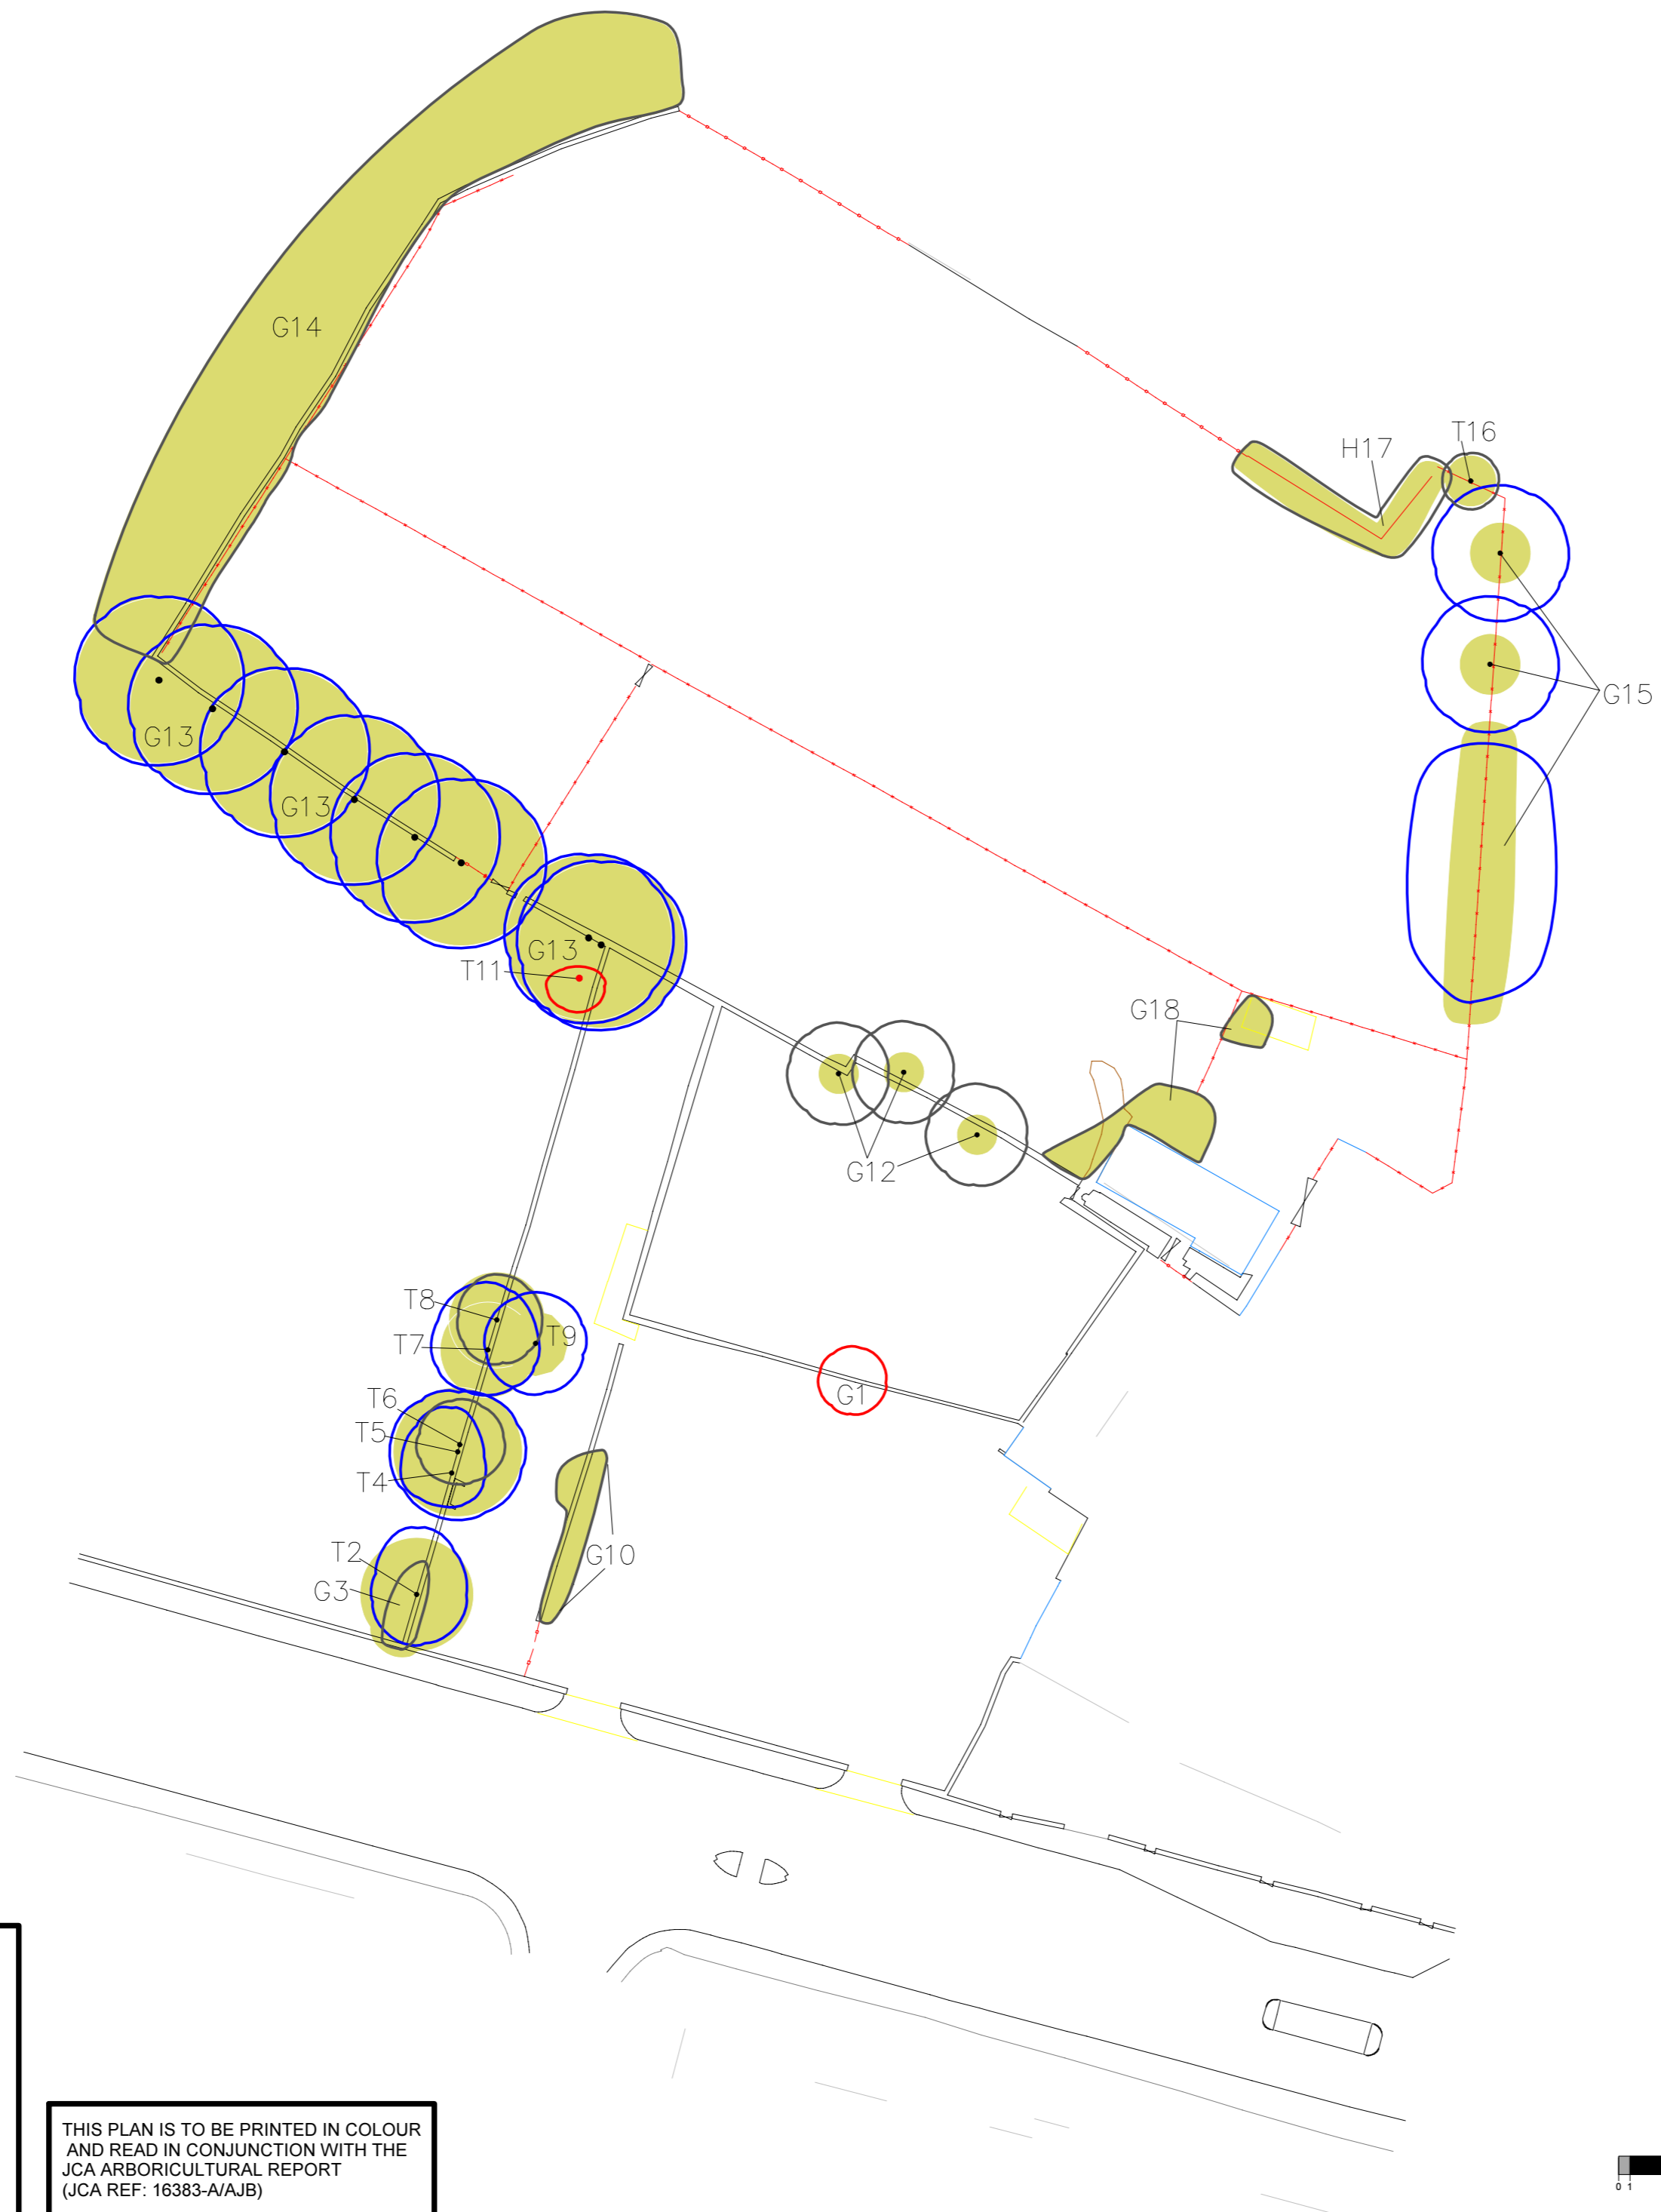
Root Protection Area: RPA

THE ROOT PROTECTION AREA (RPA) INDICATES THE LIKELY ROOTING ZONE OF A TREE. THE RPA SHOULD IDEALLY REMAIN UNDISTURBED IF A TREE IS TO BE RETAINED.

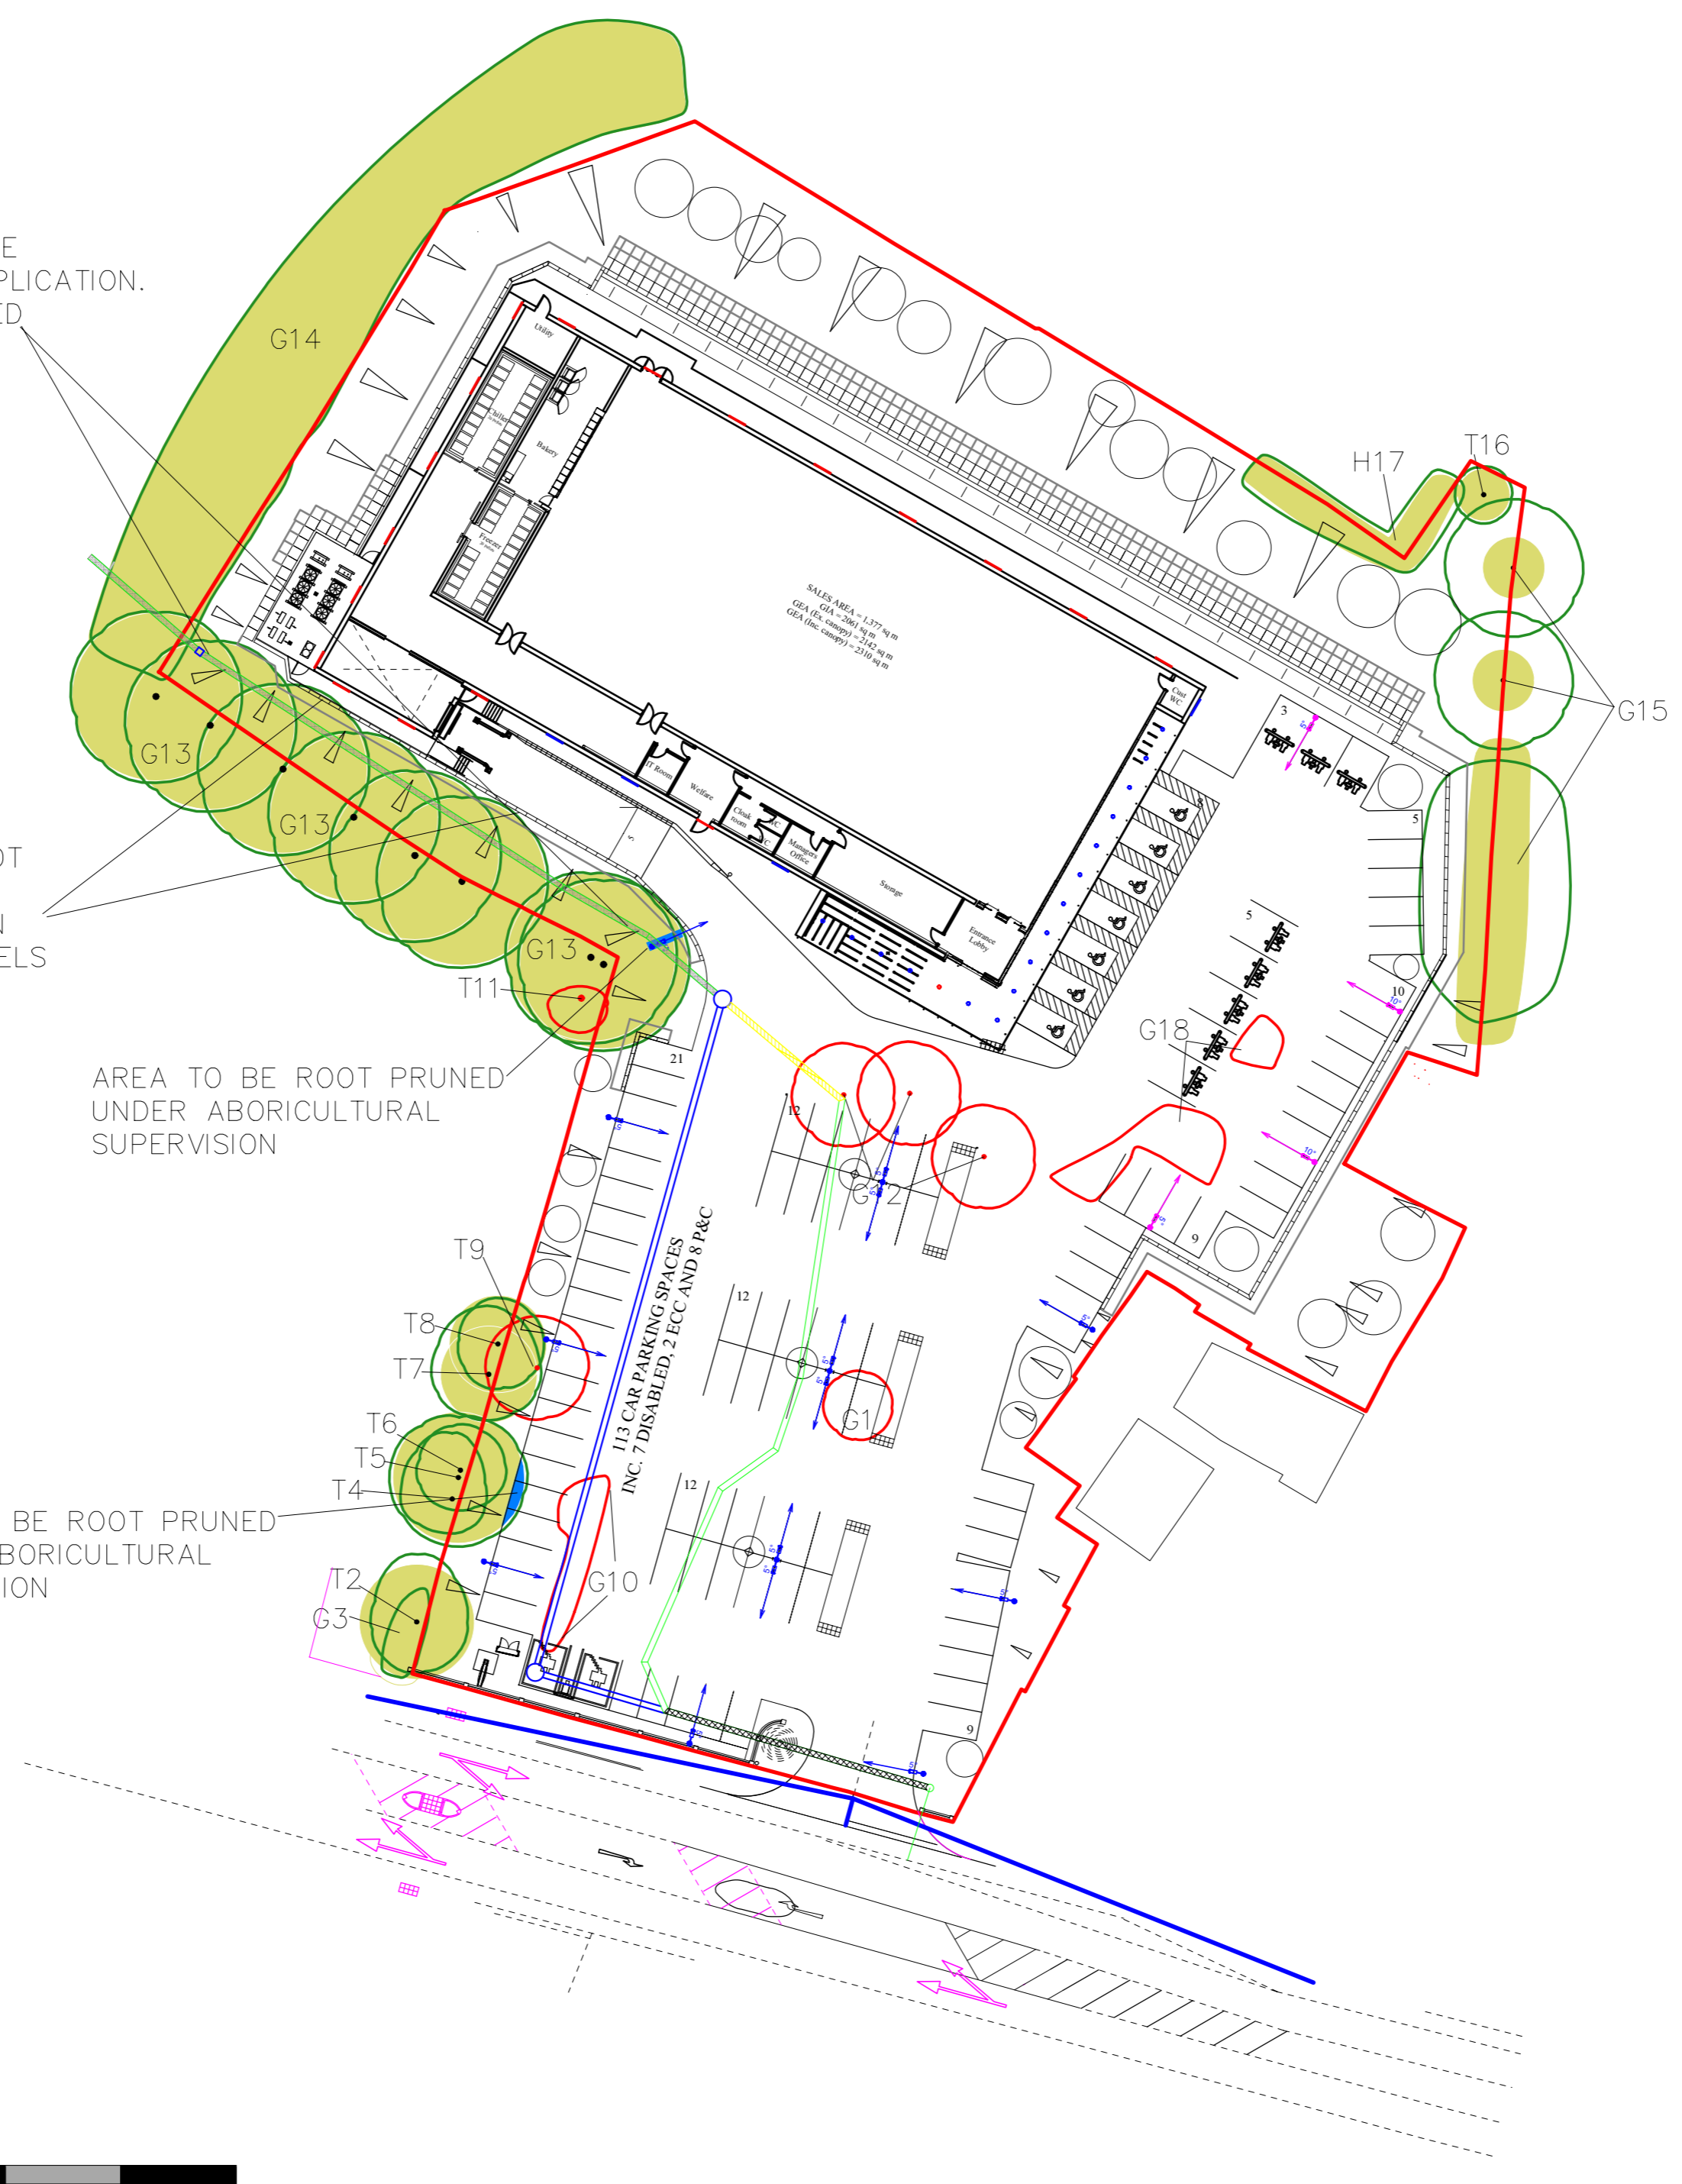
3.4.2.1 A proposed car park is located within the RPA of **T5**. Due to the minimal nature of the incursion, it is not considered necessary to install specialised surfaces. Instead, root pruning will be undertaken under the supervision of an appointed arboriculturist to prevent 'ripping' damage, which is commonly associated with mechanical excavation.

3.4.5.1 A proposed lighting column is located within the RPA of one tree within **G13**. Due to the minimal nature of the incursion, root pruning will be undertaken under the supervision of an appointed arboriculturist to prevent 'ripping' damage, which is commonly associated with mechanical excavation.

NO WORKS ARE PROPOSED FOR THE EXISTING CULVERT UNDER THIS APPLICATION. THE CULVERT DIVERSION IS LOCATED OUTSIDE TREE ROOTING ZONES

THE REAR OF THE PROPOSED RETAINING WALL IS TO BE SHEET PILED IN ORDER TO AVOID ROOT DAMAGE. THE RETAINING WALL IS TO BE CONSTRUCTED IN ORDER TO MAINTAIN THE EXISTING GROUND LEVELS WITHIN G13.

AREA TO BE ROOT PRUNED UNDER ABORICULTURAL SUPERVISION
