# WELLHOUSE

## CONSERVATION AREA APPRAISAL

This report is an appraisal of the Wellhouse conservation area, which was designated on the 31st March 1981. This report has considered and approved the proposed boundary changes of the Wellhouse conservation area.

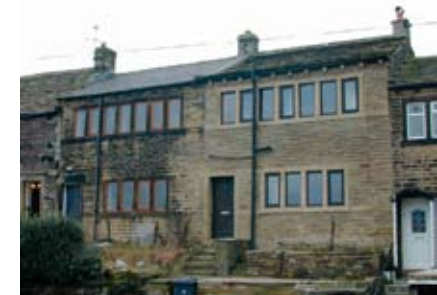
Many of the listed buildings are good examples of weavers' cottages of two and three storeys. The oldest listed building is recorded as number 8 Radcliffe Road (17th century) but number 6 Radcliffe Road incorporates a large lintel with a datestone of 1666. There is considerable alteration to number 8, possibly in the 18th and 19th century, which may have involved the removal of mullions to the first floor window.

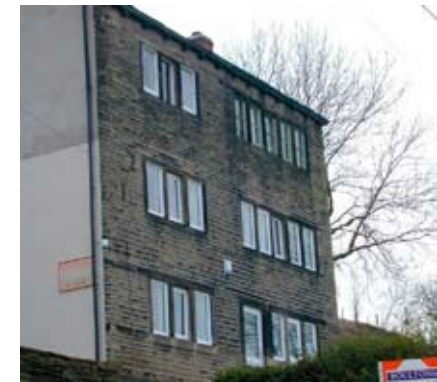
2 - 10 Copley Road

Other listed buildings include Number 2-10 Copley Bank Road, and these are back-to-back weavers' cottages of three storeys. No 50-52 Upper Wellhouse are an example of weaver's cottages of 3 storeys and a basement, which is now an underdwelling.

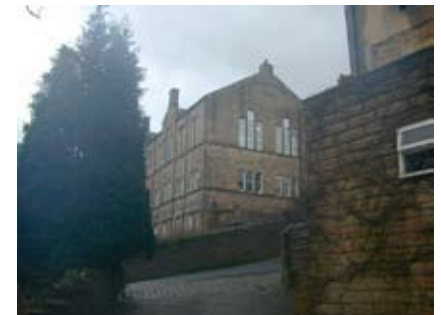
*Wellhouse Junior and Infant School*

- 39 Lower Wellhouse Road – This building, despite a number of alterations, has some interesting vernacular details including kneelers, chamfer detailing and mullion windows.
- Wellhouse Junior and Infant School (1881) is an imposing and substantial stone building at the nucleus of the village. It has some interesting detail such as the continuous sill band, well-proportioned and symmetrical windows and an inscription and stone detailing in the shape of multiple arches. It has a stone boundary wall and incorporates original gatepiers and iron gates.

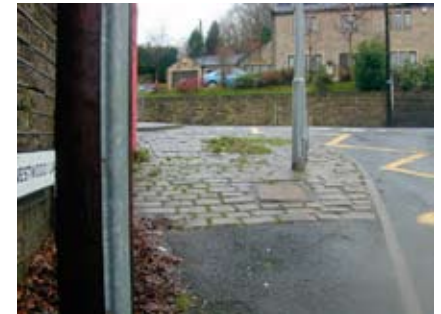
*Traditional stone setts*

There is potential to improve existing elements of street furniture such as street lighting, seating, road signage, utilities service equipment and a scheme to reintroduce traditional street surfaces could be beneficial.

Most of the historic floorscape and street furniture within the designated area has been lost. It is therefore important that where original stone flags, boundary walls, street furniture, setts, or kerbs exist that these are retained and not replaced or repaired with modern materials when highways or statutory authorities undertake any work. The public realm is therefore suffering from neglect and exhibiting evidence of a lack of an integrated approach to its management. An enhancement scheme for footpaths and bridleways should be agreed in association with Highways Department and Conservation & Design. This should include removal of litter and detritus, which collects at the kerb edges. The bus stop is out of character with the conservation area and should be replaced in a more appropriate material at the next opportunity.

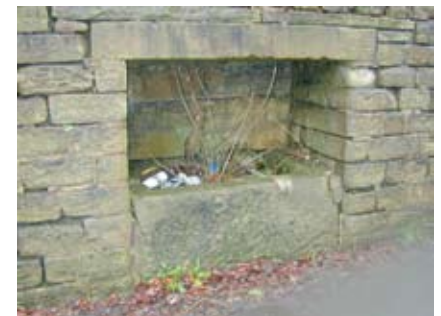
*Trough opposite school*

- Well trodden set of steps leading from Radcliffe Road to Upper Wellhouse
- Stone trough opposite the school on Lower Wellhouse Road
- Composite arrangement of troughs on Lower Wellhouse Road
- Wall mounted post box in 'pillar-box red'.
- An iconic telephone kiosk (a K6 and in need of maintenance)
- Gateposts and associated ironwork to the former New Connexion Methodist Church on Upper Wellhouse Road
- Footpath entrance gateposts and steps from Lowestwood Road

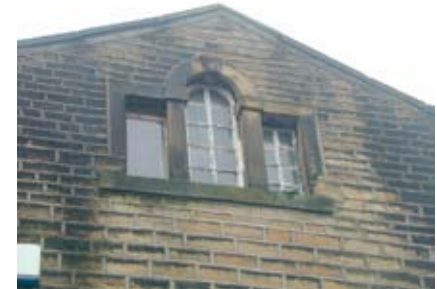
*Venetian Window*

Other listed vernacular buildings have aspects of architectural detailing such as a Venetian window at 104-106 Lower Wellhouse Road. A large number of listed buildings in the Wellhouse conservation area are listed as part of a group and therefore have Group Value.

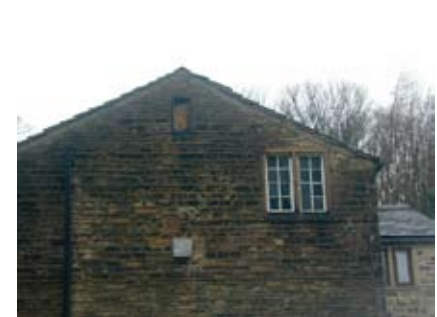
*Hoist Opening*

The weavers' cottages are constructed either in rows of terraces or in clusters, where the gable ends sometimes abut the street. Where these buildings illustrate their functionality the later terracing of the 19th century at Rob Royd and Radcliffe Terrace does not. There is evidence of buildings being used as warehouses and for storage and there is evidence of openings where hoists may have been housed.

Number 4 Radcliffe Road (c. 1840) is also listed and includes a door at the upper storeys. This was essentially used to provide a level through which materials were taken to and from the work floor. These doors tend to have been blocked but some remain in use.

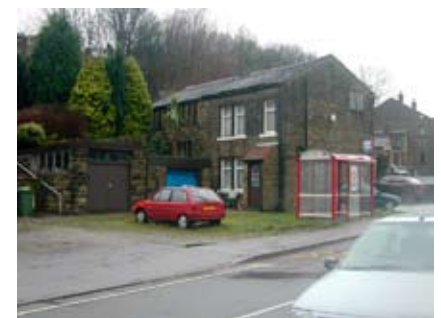
There are a number of open spaces within the public realm, which provides continuity to the building line and connectivity to the areas within the conservation area. However, there is a significant space leak at the site of the bus shelter, and despite an attempt at soft landscaping this area needs attention. A traditional surface material should be considered for this area as part of a wider strategy for surface materials in the conservation area.

*Space leak adjacent to bus shelter*

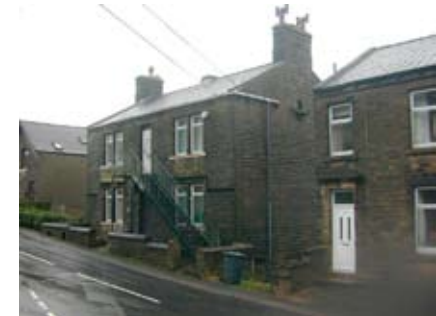
Most of the buildings in Wellhouse are in good condition. A number of buildings and signs have been targeted and defaced by graffiti, this should be removed and the signage should be replaced. There is the old Co-operative building, until recently it has been a small engineering works in the center of the conservation area, which has boarding on the windows. Although this detracts from the overall condition of the conservation area it is not a significant issue and it is hoped a sustainable new use will be found soon.

*Graffiti at Wellhouse Village Club*

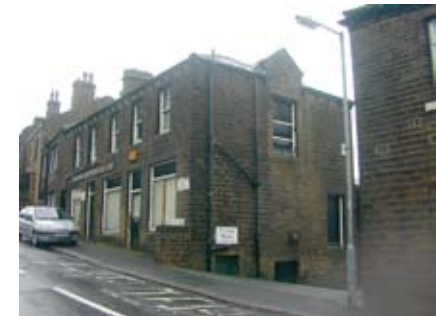
*The old Co- Operative building*

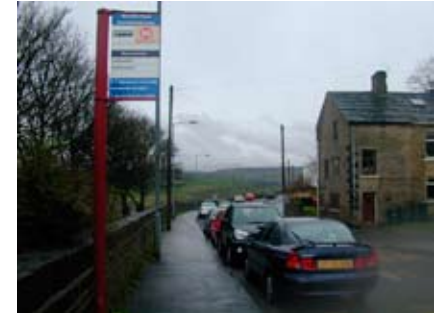
Another negative factor, which is quite pronounced, is the amount of on street parking. The area along Radcliffe Road has a stream of parked cars, which makes it difficult to drive through the settlement safely. In response traffic calming has taken the form of large white painted lettering at major gateways and access points, which can be detractive within the conservation area.

*On street parking*

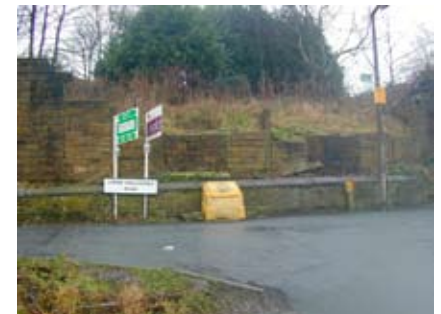
The graveyard is significant as it connects with the historical past of the conservation area and should therefore be afforded maintenance and enhancement. The areas surrounding the remaining boundary walls of the church appear in a state of disrepair and should be included in the improvement scheme to tidy up the area. It is hoped that the Wellhouse Community Trust may create a small natural park in the graveyard and improve access into the area, which includes graves for servicemen from both World Wars, and this should be encouraged.

*Walls and area on Lower Wellhouse Road*
