**DETAILED ASSESSMENT
OF AIR QUALITY
(PM10)**

**SCOUT HILL
A644 HUDDERSFIELD RD
DEWSBURY**

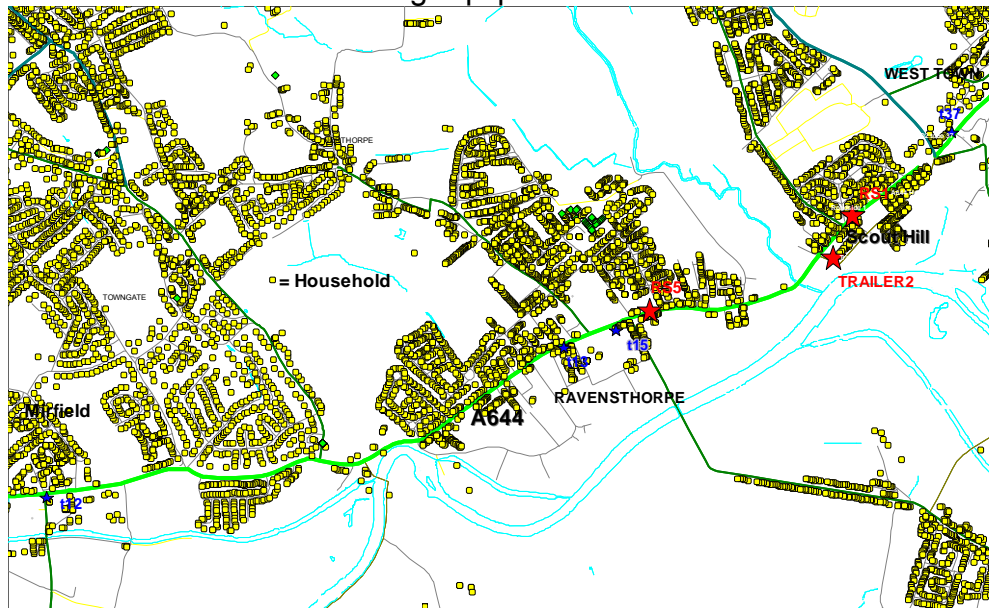
The map below shows the location of households along and in the corridor and the location of monitoring equipment

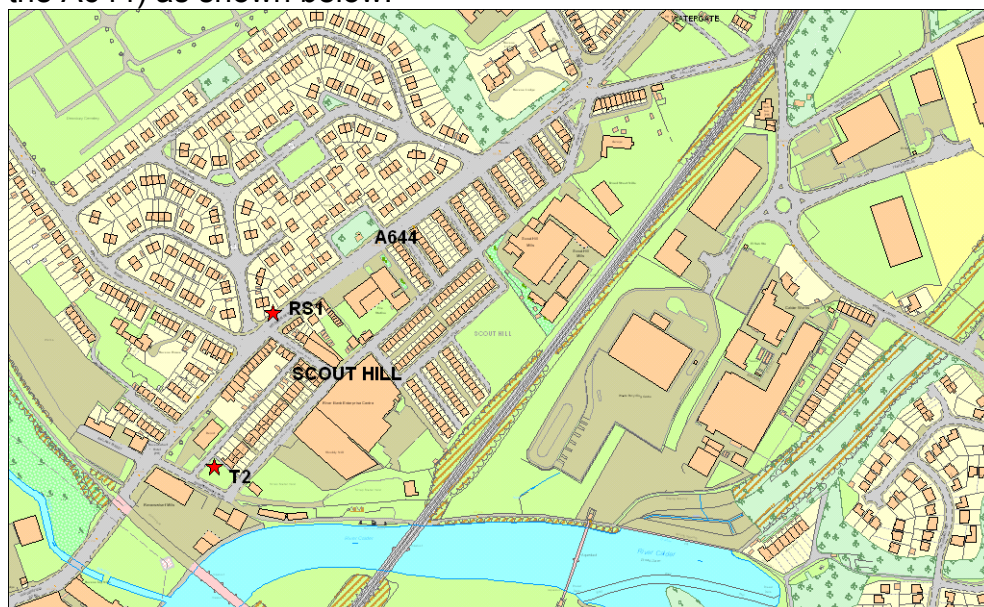
The housing in this area is a mix of terraces, semi-detached and detached properties. In the Scout Hill area there are mainly semi-detached properties to the north of the road and terraces to the south of the road which are arranged at right angles to the A644 (i.e. the gable end of a terrace faces on the A644) as shown below.

This map also shows the locations of the RS1 and T2 monitoring stations.

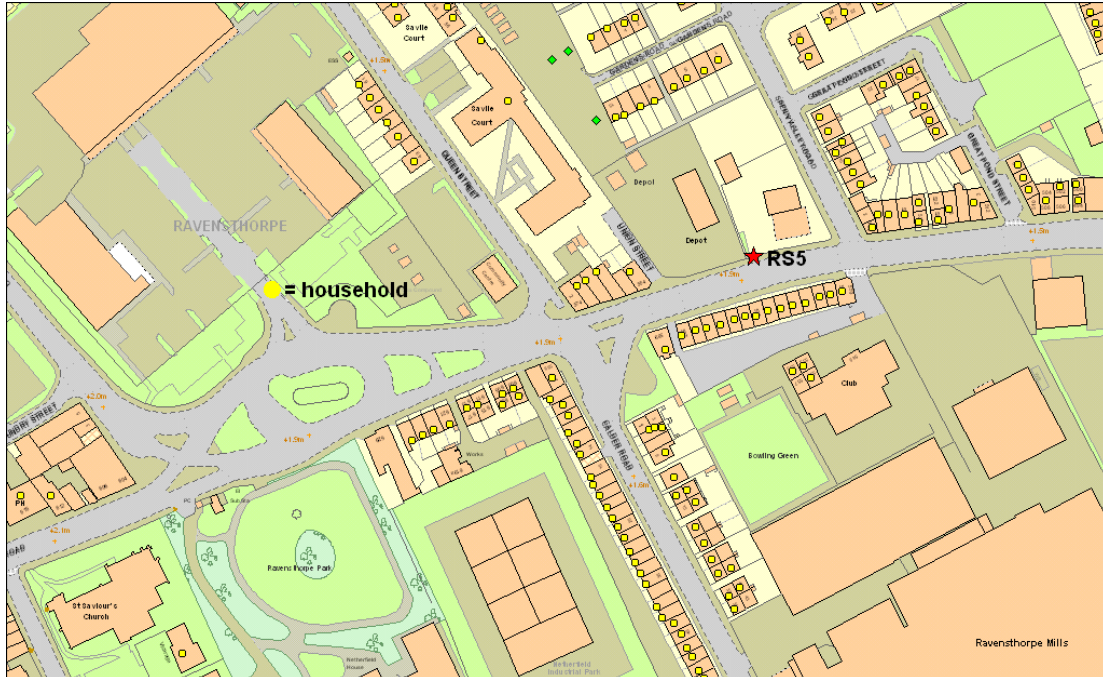
The monitoring station RS5 is located 850m to the south-west of the Scout Hill monitoring station RS1, and it is situated roadside outside a Council building near to the Ravensthorpe Gyratory System. It is the same distance from the road centre line as the households 38m away on the north side of the road. The arrangement is shown in the map below:

The orientation of the road here is similar to that at Scout Hill, with the road here being 20 degrees more to the E-W axis and it has the same traffic characteristics as Scout Hill.

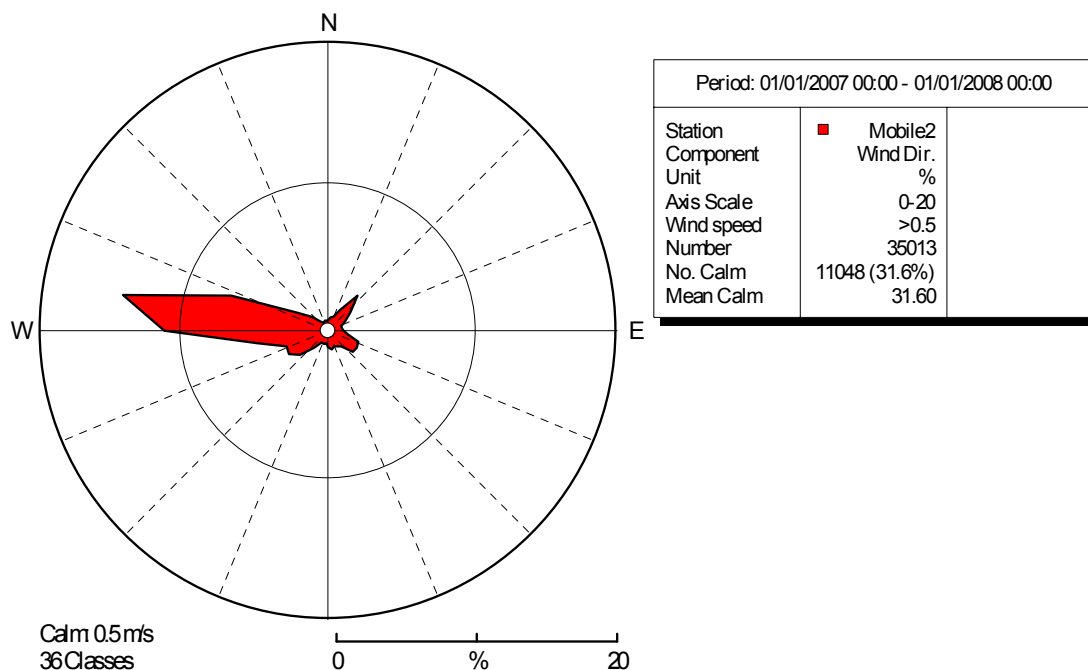
Wind rose

The wind rose for the year shows the prevailing wind direction

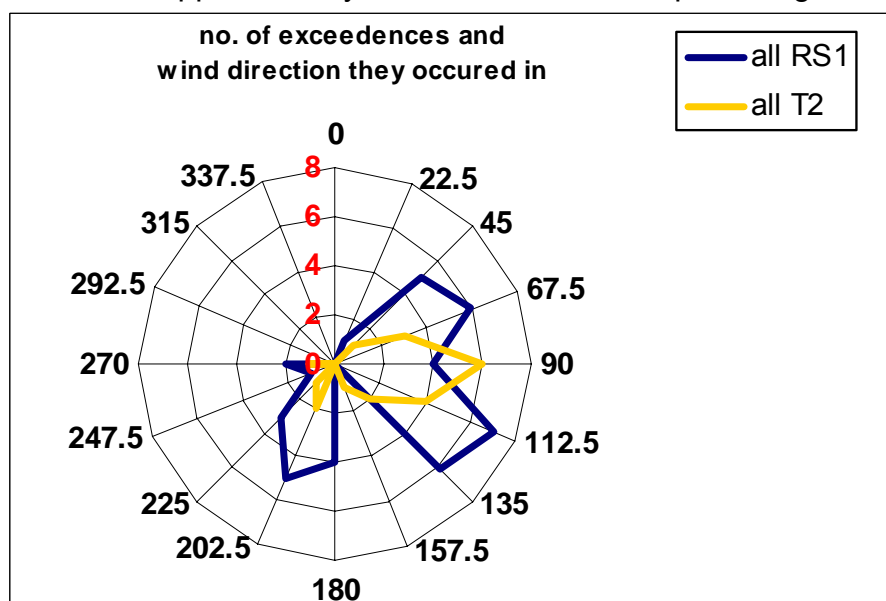
However the daily average wind directions for the days of exceedence give a clear picture of how the wind directions correlate with exceedences. It is noteworthy that **only** 2 of the daily exceedences at RS1 are when the wind direction is approximately in the direction of the prevailing wind.

The wind directions are the centre directions of one sixteenth sections of the compass circle and are show by the black figures around the “web”. The red figures represent the scale for the number of exceedences in each direction.

There are no exceedences measured when the wind direction is the compass “quadrant” W – NE. For the RS1 station that is exactly the wind direction sector that would take the traffic source pollution away from the station. For the Trailer 2 station one would expect the road traffic contribution to cause exceedences from this quadrant. However Trailer 2 has a minimum distance to the A644 road centreline of 47m whereas for RS1 it is 7m and it is highly probable that this accounts for the seeming anomaly.
