# Kirklees Council Flood Investigation *6 Enfield Close, Batley*

Flood Management and Drainage Team  
Kirklees Council  
1/23/2012

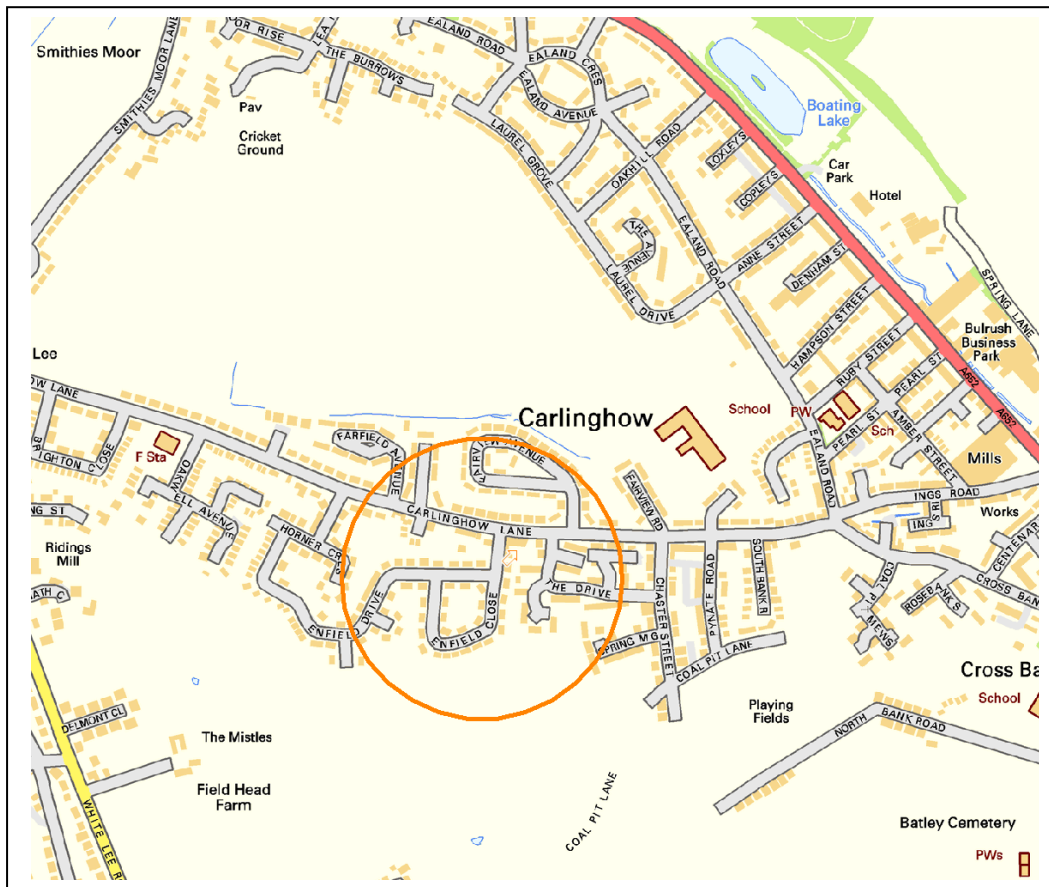
## 2. Location of Flooding

6 Enfield Close (Box's Buildings) is a late 19<sup>th</sup> century property in a complex of back to back properties at the junction of Enfield Close and Carlinghow Lane, Batley.
